BASELINE WASTE CHARACTERIZATION STUDY

LEONSBERG PARMARIBO, SURINAME

SEPTEMBER 2025

ON BEHALF OF GREEN HERITAGE FUND SURINAME

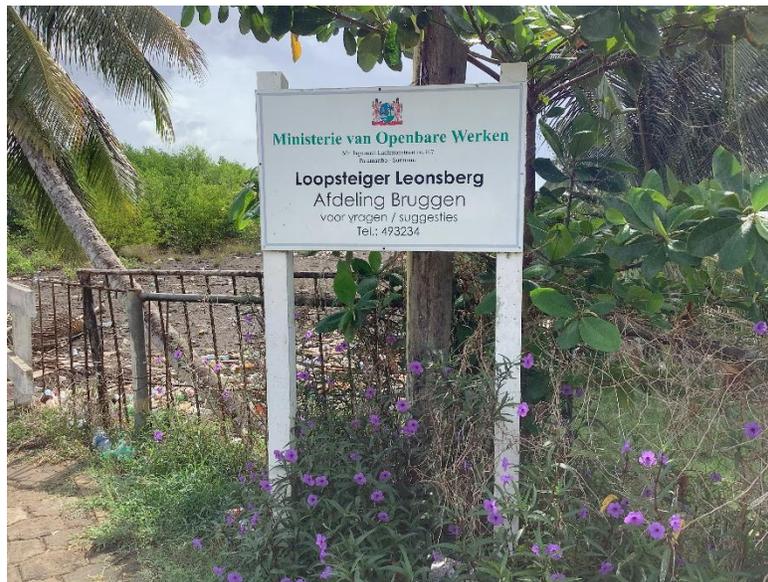
Figure 1 Entrance Leonsberg Jetty

The Leonsberg Jetty (figure 1), also known as the Ferry Terminal Leonsberg, is located in the Blauwgrond resort area in northern Paramaribo along the Suriname River (Coordinates: 5.86984, -55.09818) (Figure 3). Built in 1913 to support crossings between plantations, the jetty has evolved into a multifunctional site. Today it is used for informal ferry services, dolphin-spotting excursions, and as a gathering point for residents and tourists. Small eateries and informal seating areas around the terminal make it a popular space for both daily transport and leisure (figure 2).

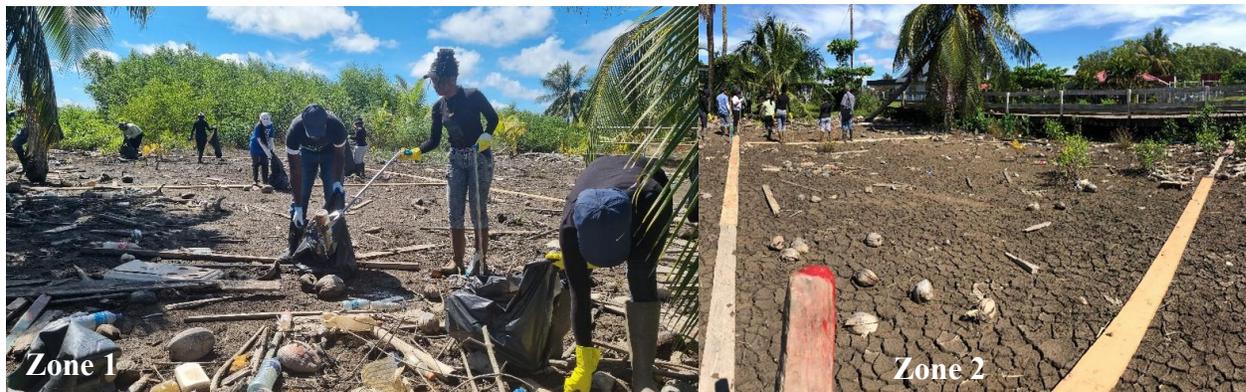
Figure 4 Zone 1 and 2 of the study area at Leonsberg

The site was divided into two zones, based on location and usage (Figure 4):

- Zone 1 (Front): Closest to the riverbank and coconut trees, with a high concentration of organic and bulky waste.
- Zone 2 (Rear): Slightly inland, flatter and partially vegetated, with scattered lightweight waste.

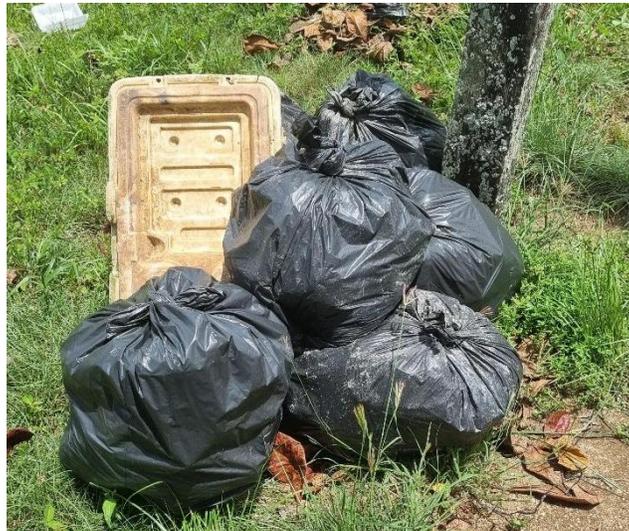
Sorting began once all the waste had been removed from the entire study site. Data was recorded in the Solid Waste Sampling on Beaches Data Recording and Analysis Tool. After characterisation (figure 5), waste was bagged and stored at a central collection point (figure 5), from where it was removed by the Directorate of Waste Collection and Processing (Ministry of Public Works).

Figure 5 Waste placed at collection point at the end of the activities

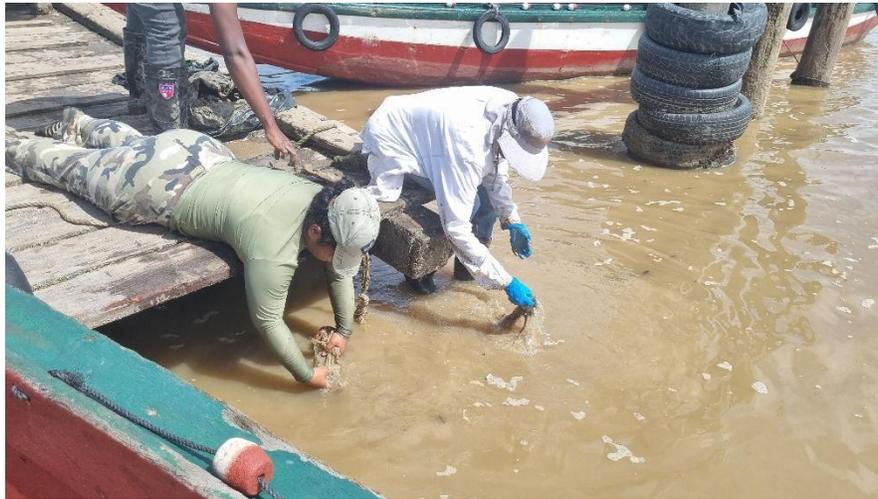
During the baseline cleanup, the weather had been sunny and the study area was dry; however, the second and last cleanup happened after heavy rains, resulting in a very muddy study area with waste that was caked in mud. In order to get somewhat accurate weights, the waste was washed in the river during the second cleanup and in a large tub during the third cleanup (figure 6). This also had an impact on the weight of the waste.

Figure 6 Waste being washed in the Suriname river

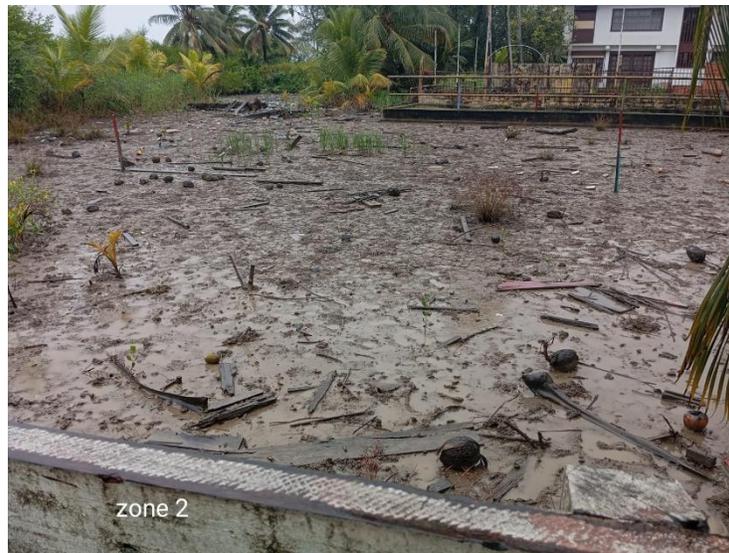
Following the baseline cleanup and the first measurement, the demonstration site was observed for a two-week period. Every day, the site was visited to document accumulated waste and any additional activities through photographs (figure 8).

Figure 7 Picture of zone 2 taken during observation period

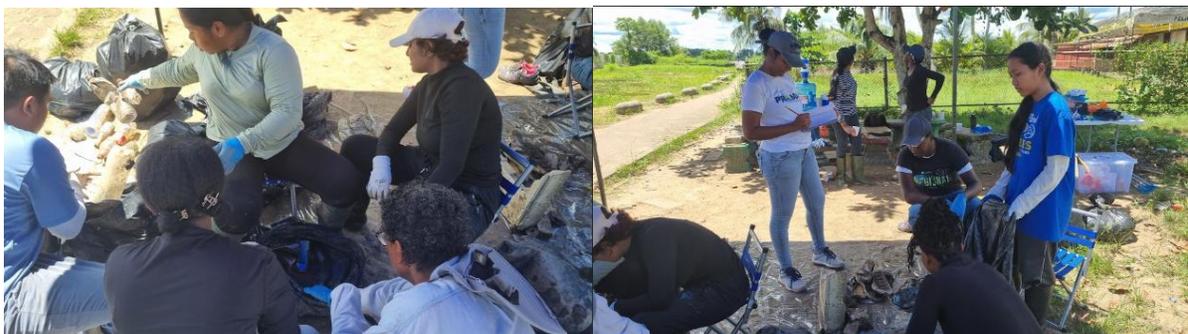
For each sampling round, the collected waste bags from Zone 1 and Zone 2 were emptied and separated according to the PROMAR guidelines. The collected waste was fully sorted and characterized on-site, including collection, weighing, sorting, and registration. Figure 9 shows impressions from the sorting activities. During the sorting activities, any items containing liquid were emptied, and items covered in mud were cleaned prior to weighing and categorization.

Figure 9 Field impressions of the sorting and waste characterization process

All separation activities were conducted at the field station using plastic sheets, gloves, and standardized sorting protocols. Waste was grouped by material type, weighed, counted, and recorded for further analysis in accordance with the PROMAR-adapted BlueBox methodology.

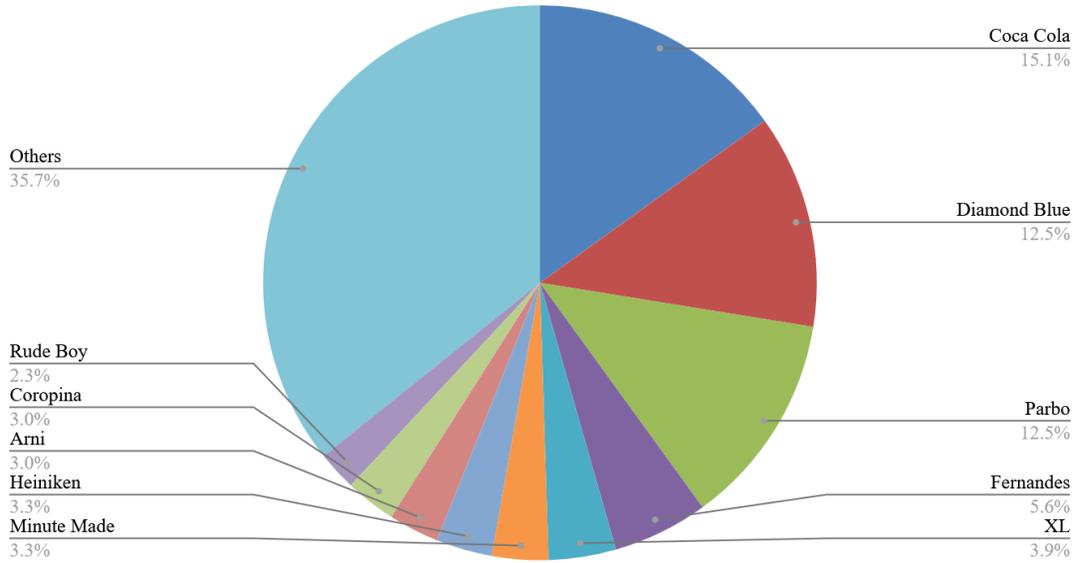
Figure 10 Top 10 Brands identified (in %) 10-05-2025

During the cleanup on 10 May, 305 items were found with identifiable brands, and a total of 66 brands were identified (Figure 10). On 24 May, 81 items were found with identifiable brands, and 39 brands were identified (Figure 11). During the last cleanup on 7 June, 77 items were found with identifiable brands and 34 brands were identified (Figure 12).

The analysis of branded waste provides further insight. Coca-Cola, Diamond Blue, Parbo, Fernandes, and Heineken were repeatedly identified, pointing to both local and international beverage companies as significant contributors to the waste stream. However, the overall proportion of branded items declined significantly after the first round, with unbranded materials increasing from 50% to more than 80%. This suggests two important dynamics: first, that visible beverage packaging is only a fraction of the total waste problem, and second, that unbranded or degraded plastics, difficult to trace back to producers, make up the bulk of environmental litter. These findings reinforce the need for interventions that go beyond brand accountability to include systemic improvements in local waste collection and disposal.
