BASELINE WASTE CHARACTERIZATION STUDY

LONG BAY BEACH, BEEF ISLAND, BRITISH VIRGIN ISLANDS

OCTOBER 2025

ON BEHALF OF GREEN VI

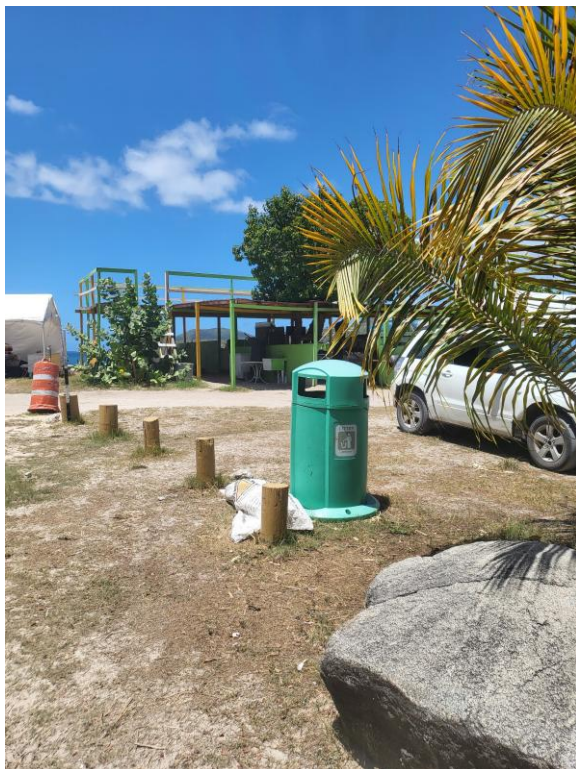
Figure 2: One of three small public bins by carpark

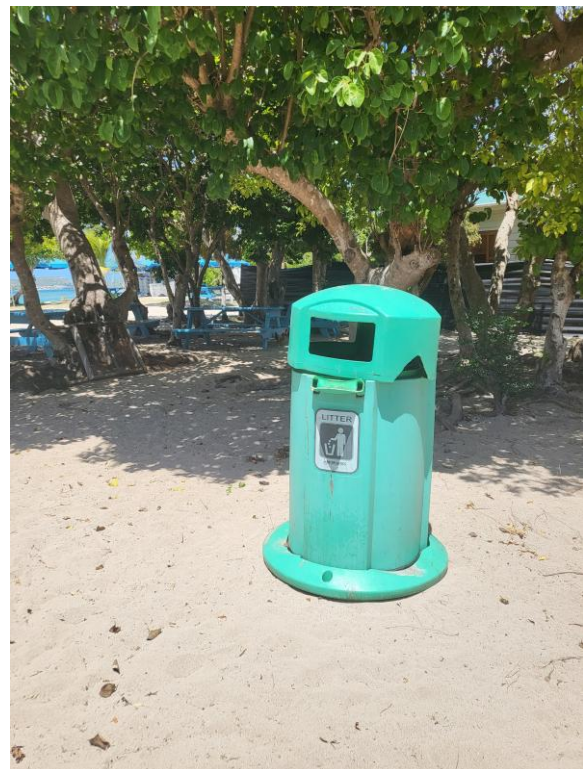
Figure 3: Another small public bin by beach bar Moose on the Beach

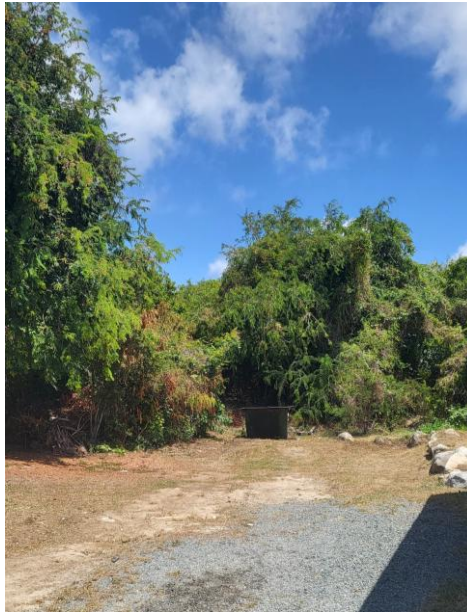
Figure 4: Large skip bin located to the back of the beach and carpark area. All waste ends up in here and then eventually landfill.

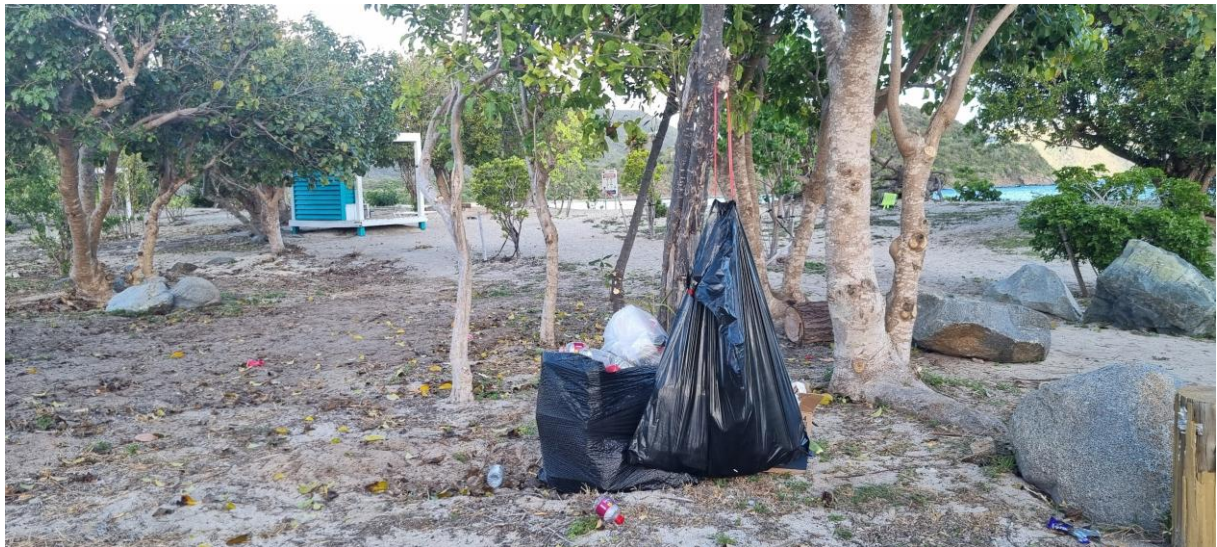
Figure 7: View of ‘Picnic Area’ from car park, with blue cabana marking the sample transect area. Presence of black rubbish bags in foreground are common due to no waste receptacles in the area.

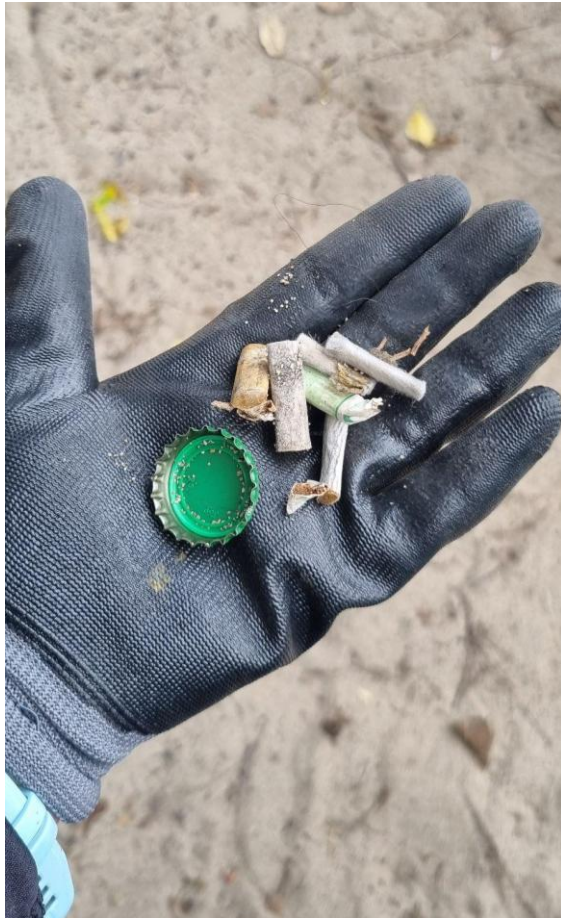
Figure 8: Cigarette Butts and metal bottle caps are common items found

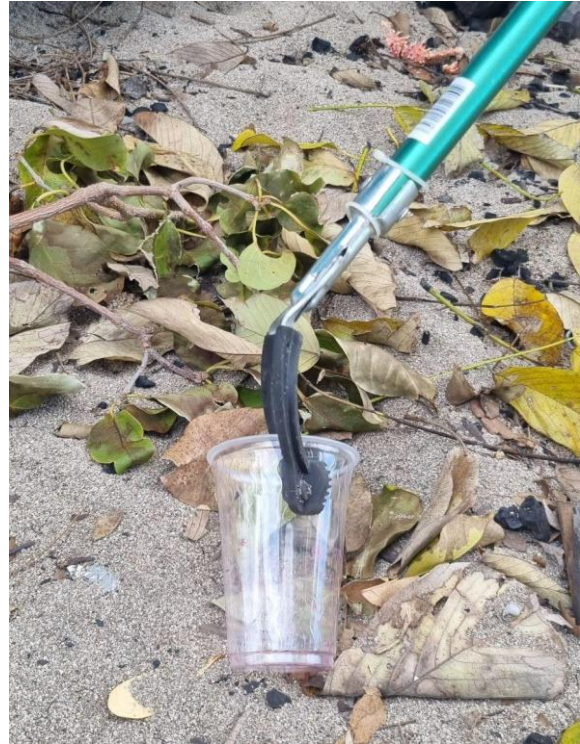
Figure 9: Plastic cup discarded within Vendor Area

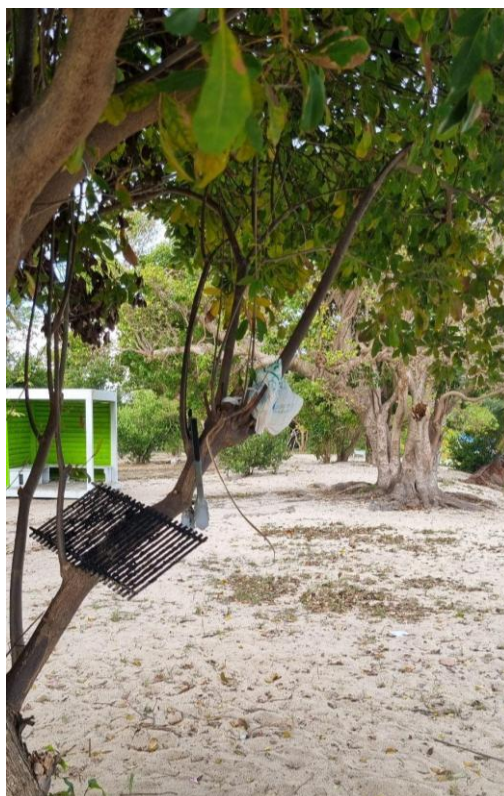
Figure 10: Litter stashed in a tree within sampling transect

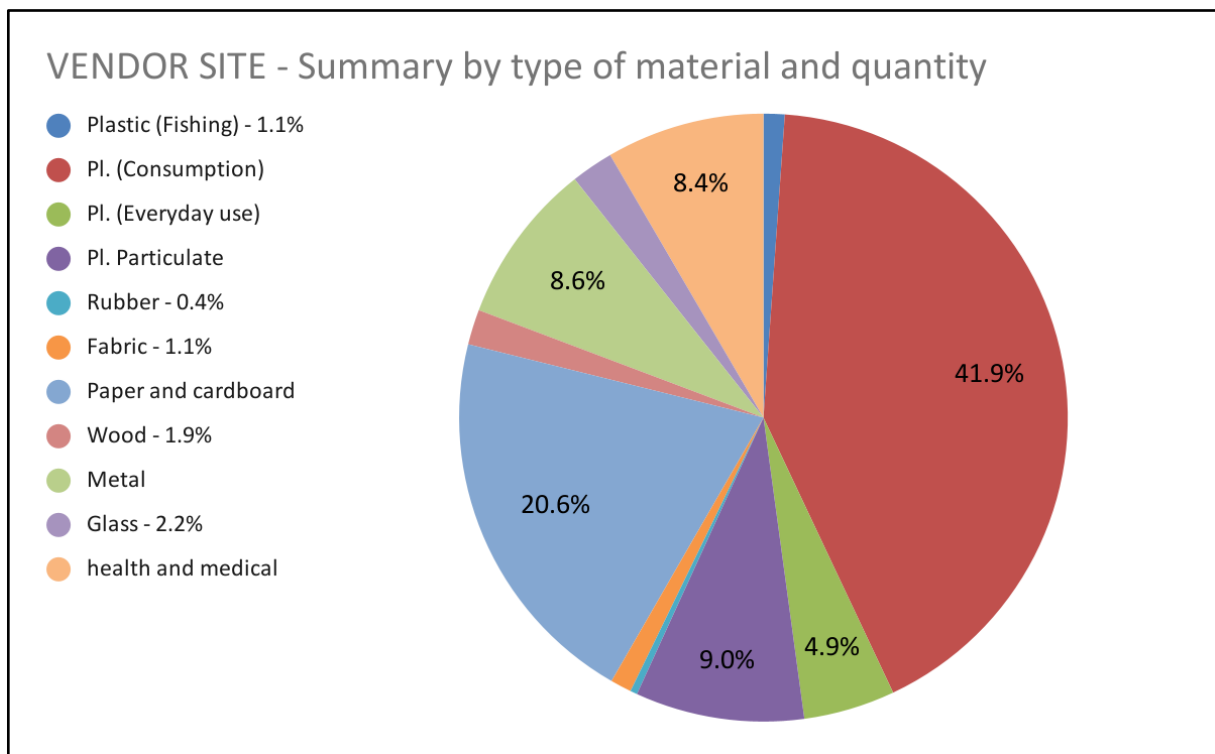
Data from the five sampling activities were analysed and the pie chart below represents the average litter distribution by material type. Plastics dominate the litter types found within the vendor area, representing over 50% of the total litter collected. On average, within the vendor transect area, 50 items could be found, weighing approximately 658 grams.

Figure 12: Pie Chart summary of litter items from within the Vendor Area.

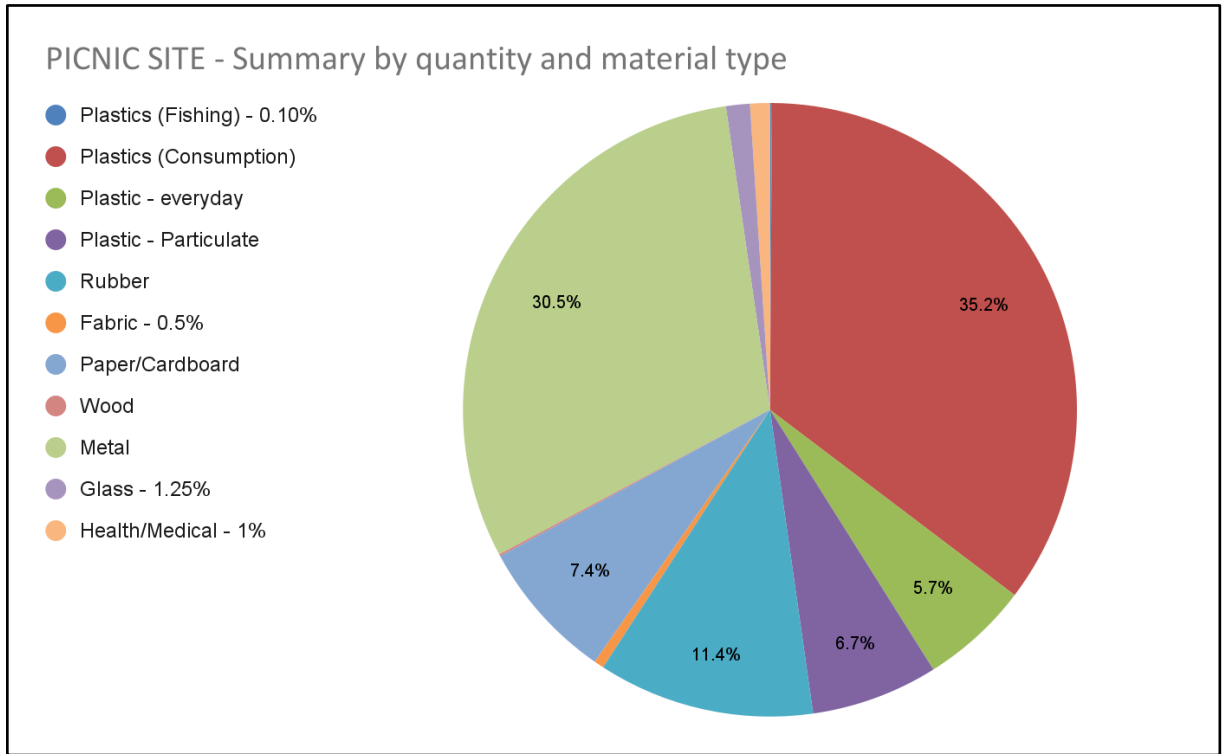
The pie chart below shows the average quantity by material type across the five samplings. Plastics form just under 50% of the items found. The 2nd most common material type found was metal, specifically metal bottle caps. On average, 192 litter items were collected each time, weighing 705 grams.

Figure 13: Pie Chart summary of litter items from within the Picnic Area.

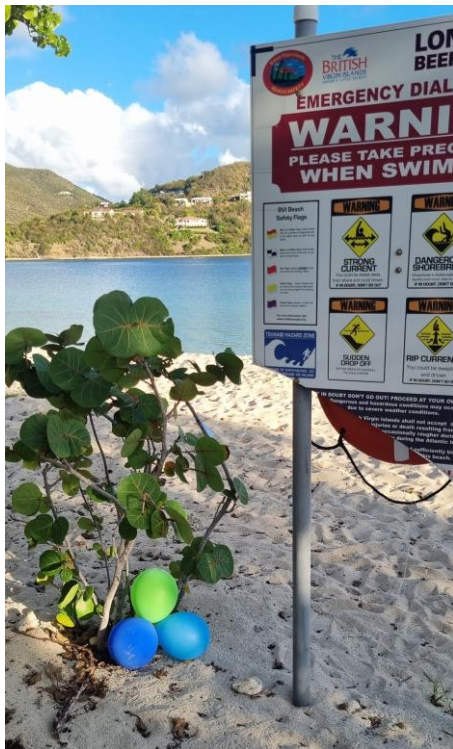
Figure 14: Balloons within Picnic area

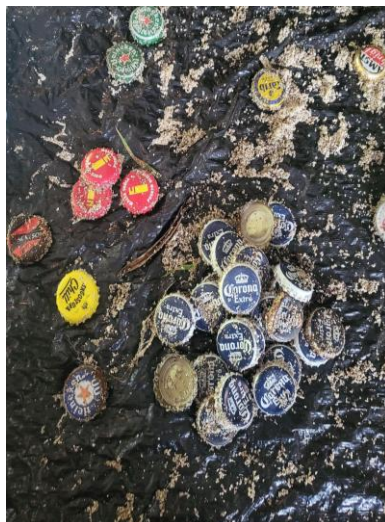
Brand information helps to identify what the litter items are, as well as where they came from, and will help to inform targeted campaigns for litter reduction. The top brand recorded across all litter items and transacted areas was Corona.

Figure 18: Corona bottle caps
