BASELINE WASTE CHARACTERIZATION STUDY

LEONSBERG PARMARIBO, SURINAME

SEPTEMBER 2025

ON BEHALF OF GREEN HERITAGE FUND SURINAME

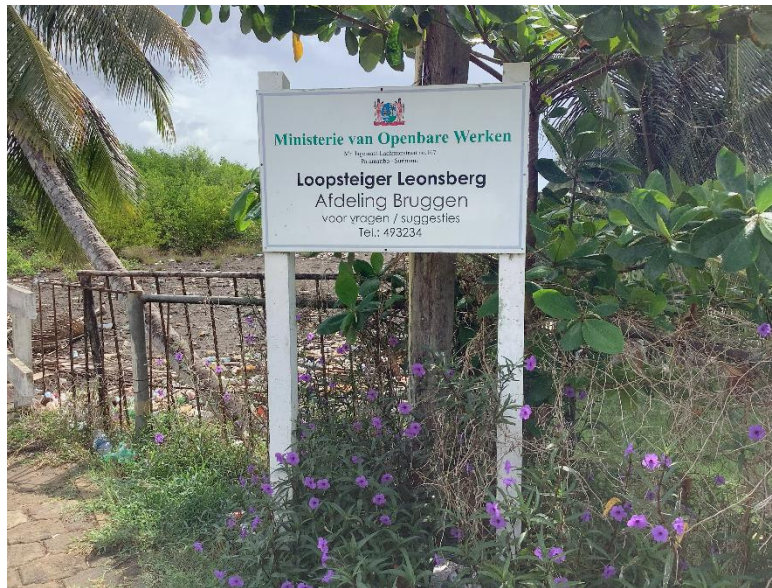
Figure 1 Entrance Leonsberg Jetty

The Leonsberg Jetty (figure 1), also known as the Ferry Terminal Leonsberg, is located in the Blauwgrond resort area in northern Paramaribo along the Suriname River (Coordinates: 5.86984, -55.09818) (Figure 3). Built in 1913 to support crossings between plantations, the jetty has evolved into a multifunctional site. Today it is used for informal ferry services, dolphin-spotting excursions, and as a gathering point for residents and tourists. Small eateries and informal seating areas around the terminal make it a popular space for both daily transport and leisure (figure 2).

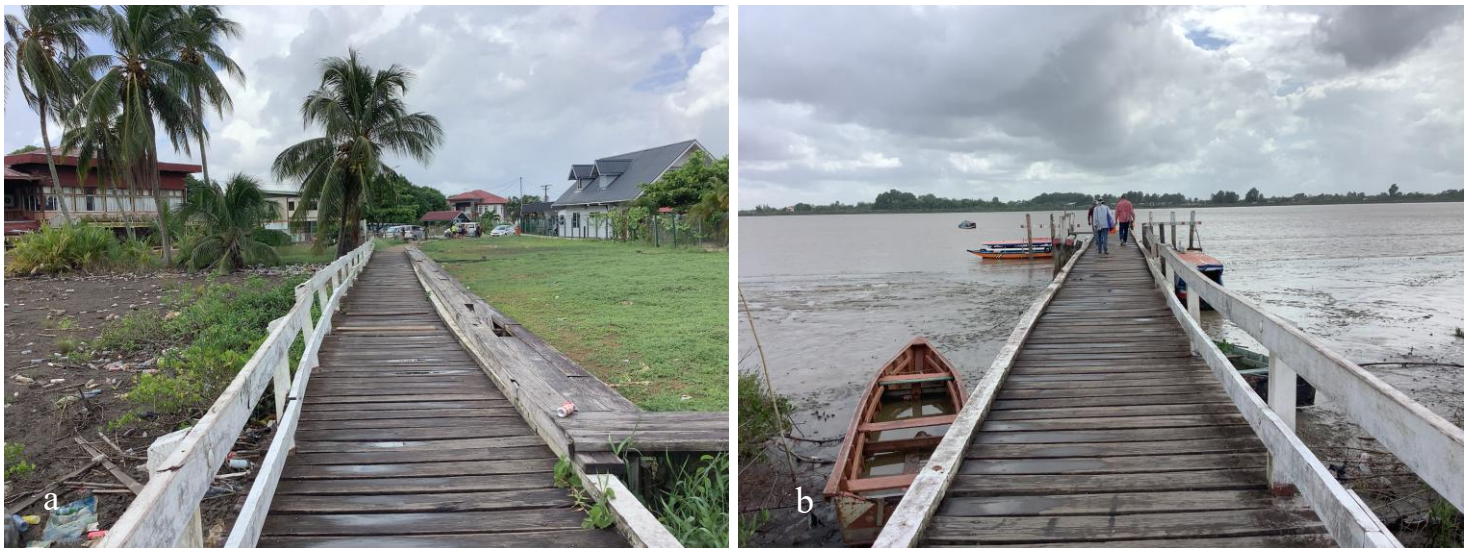
Figure 2 Leonsberg Jetty facing the road (a) and facing the Suriname river (b)

Despite its social and ecological value, the jetty faces persistent waste management challenges. Plastics, food packaging, glass, and organic waste accumulate due to the lack of permanent bins, irregular collection, and informal activities. Proximity to the river allows waste to enter aquatic environments, fragmenting into microplastics that threaten ecosystems and food safety. Various community groups, NGOs, and environmental organisations have organized cleanups to remove waste and highlight the issue of pollution at the location; however, the absence of structural waste management at the site has allowed littering and illegal dumping to persist. The need for regular,

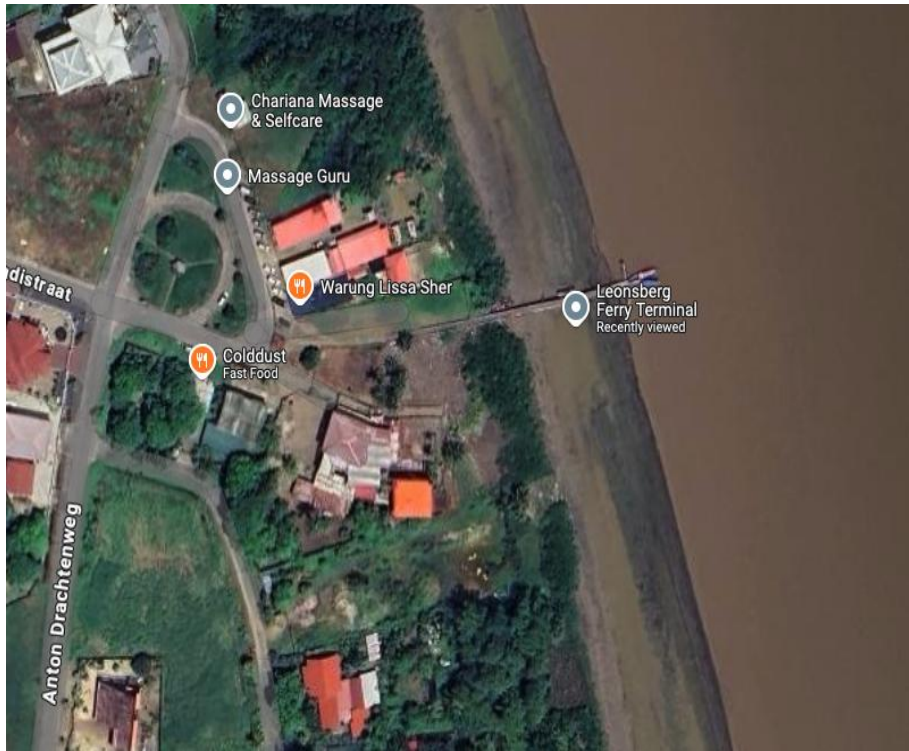
Figure 3 Satellite image of Leonsberg and the study area (red dot)

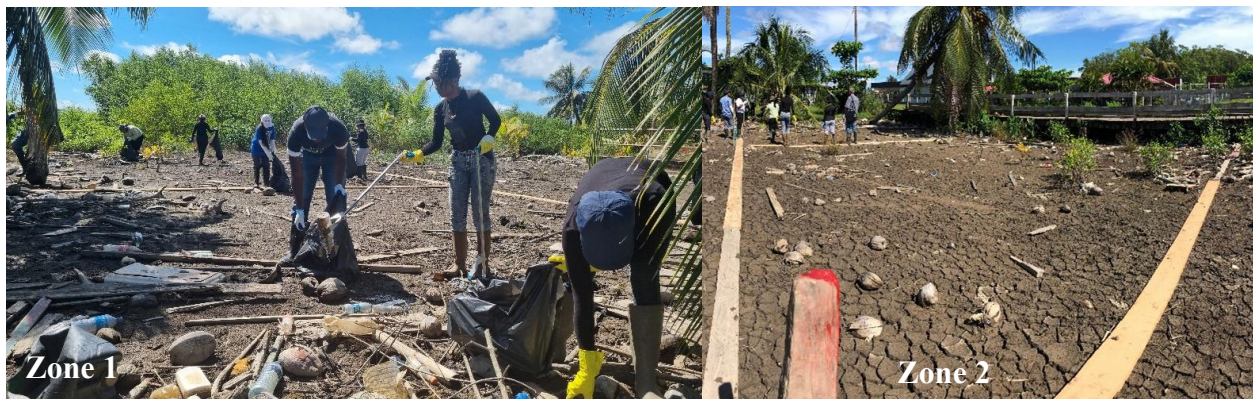
Figure 4 Zone 1 and 2 of the study area at Leonsberg

The site was divided into two zones, based on location and usage (Figure 4):

- Zone 1 (Front): Closest to the riverbank and coconut trees, with a high concentration of organic and bulky waste.
- Zone 2 (Rear): Slightly inland, flatter and partially vegetated, with scattered lightweight waste.

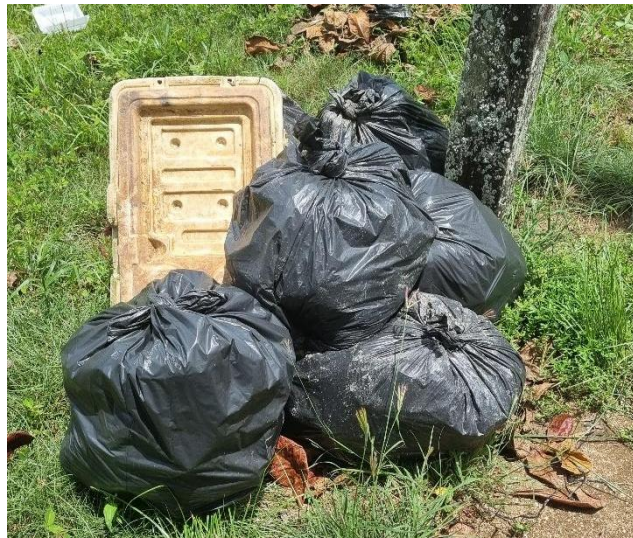
Figure 5 Waste placed at collection point at the end of the activities

Sorting began once all the waste had been removed from the entire study site. Data was recorded in the Solid Waste Sampling on Beaches Data Recording and Analysis Tool. After characterisation (figure 5), waste was bagged and stored at a central collection point (figure 5), from where it was removed by the Directorate of Waste Collection and Processing (Ministry of Public Works).

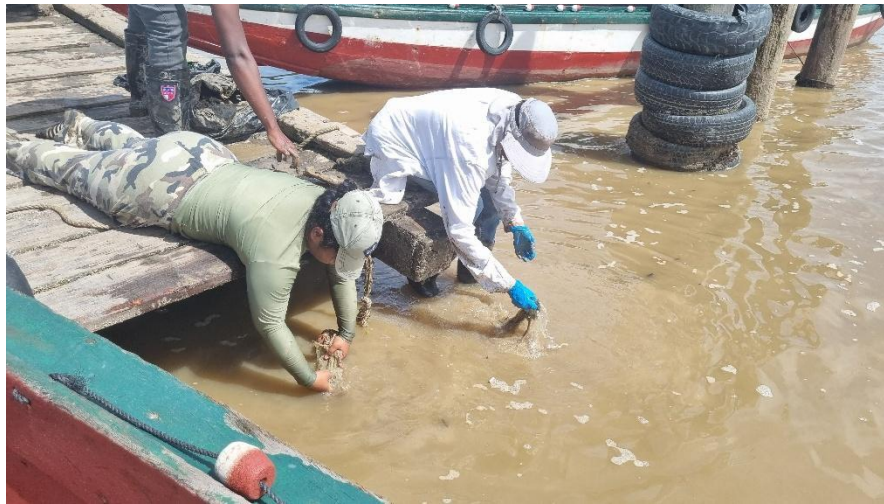
Figure 6 Waste being washed in the Suriname river

During the baseline cleanup, the weather had been sunny and the study area was dry; however, the second and last cleanup happened after heavy rains, resulting in a very muddy study area with waste that was caked in mud. In order to get somewhat accurate weights, the waste was washed in the river during the second cleanup and in a large tub during the third cleanup (figure 6). This also had an impact on the weight of the waste.

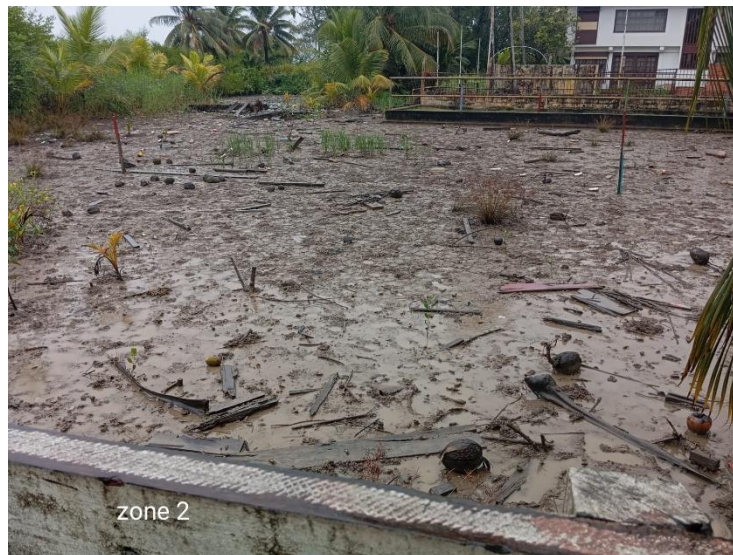
Figure 7 Picture of zone 2 taken during observation period

Following the baseline cleanup and the first measurement, the demonstration site was observed for a two-week period. Every day, the site was visited to document accumulated waste and any additional activities through photographs (figure 8).

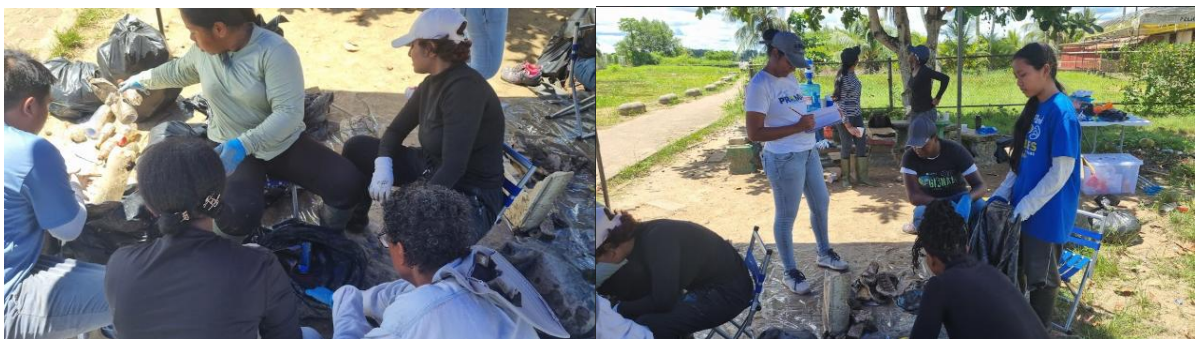
Figure 9 Field impressions of the sorting and waste characterization process

For each sampling round, the collected waste bags from Zone 1 and Zone 2 were emptied and separated according to the PROMAR guidelines. The collected waste was fully sorted and characterized on-site, including collection, weighing, sorting, and registration. Figure 9 shows impressions from the sorting activities. During the sorting activities, any items containing liquid were emptied, and items covered in mud were cleaned prior to weighing and categorization.

All separation activities were conducted at the field station using plastic sheets, gloves, and standardized sorting protocols. Waste was grouped by material type, weighed, counted, and recorded for further analysis in accordance with the PROMAR-adapted BlueBox methodology.
